Urgent Recall for Product Correction
Invacare Birdie Lifter Series– alert for the correct assembly of D-Clip and quick release pin.

ARTG: 166395

Date: 06/10/2016

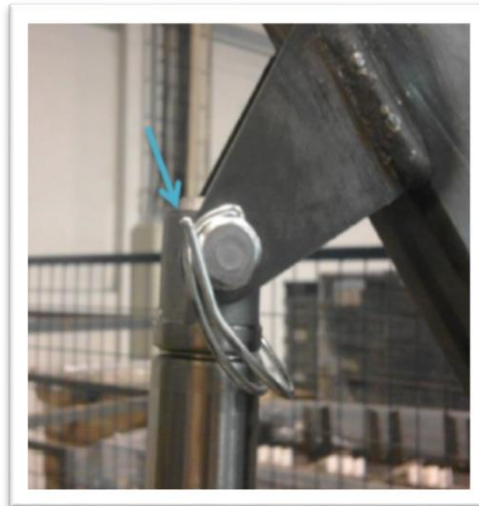
As a result of some vigilance cases overseas, where the actuator's D-Clip becomes damaged and the lifter arm falls down, we have become aware that if the D-Clip is always placed backwards and pointing down towards the actuator, it can start to become damaged after a number of cycles – picture below. If the D-Clip becomes damaged to the extent that the lifter arm falls down then there is potential for a serious patient injury to occur. When the clip is in the wrong position the bending (damage) of D-Clip only happens if it is touching the actuator backwards and at its maximum height, the clip will also bend severely when over 140kg is used with the device. The complete Clevis Pin (quick release pin) doesn't detach immediately from the actuator, when the D-Clip becomes damaged - the pin stays in the arm's plates that hold the actuator.

Whilst Australia has not received reports of customers incorrectly assembling the device, in order to prevent the possibility of the D-Clip becoming damaged the manufacturer has updated the product's instructions for use to communicate in more detail the correct way to assemble the D-Clip and quick release pin.

- The actual state of the D-Clip (Does it appear bent or broken, like in the image above)
- The actual position of the D-Clip in the lifter (if mounted)
 - If it is in the correct position shown below in picture 1, there is no need to change it
 - If it is assembled in the wrong position shown below in picture 2,
 - Remove the D-Clip and reassemble it as shown in picture 1
- Complete the attached Customer Acknowledgement Form.
- If the D-Clip appears damaged or broken please contact Invacare on 1800 460 460 or email recalls@invacare.com.au.
